Mason Caubarreaux, Cory Franklin, Luz Arrieta-Jimenez, Linda Strauss, Mr. Jason Church1, Mary Striegel1, Jafar F. Al-Sharab2, Adeal Sobhe Matuk3 1National Center for Preservation Technology and Training, 645 University Parkway, Natchitoches, LA 71457 2Department of Engineering Technology, Northwestern State University, Natchitoches LA 71457 3 Department of Materials Science and Engineering, Rutgers University, 607 Taylor Rd, Piscataway, NJ 08854

Antique, or low fire, brick has suffered critical damage from mortar repairs of Portland Cement in the US, specifically water damage as moisture cannot move equally through low fire brick and Portland Cement. Effects of such an intrusion of water include spalling, stains, efflorescence, algae growth, and a decrease in insulating properties. The best way to continue preservation is to block moisture from entering the brick or mortar by using a water repelling penetrant. This research will compare the most widely used penetrants, siloxane and room temperature vulcanizing (RTV) silicone on lowfire brick and determine which product is best for preserving the masonry. Water repelling abilities as well as water vapor permeability will be tested

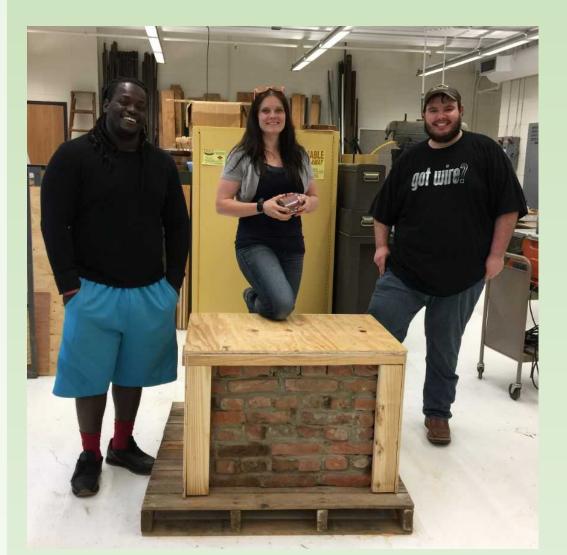
Mock Structure

A mock structure was used to test the two performance categories with a RILEM tube
